## Weartech® SHS™ Coating and Overlay Wear Plate

Extend Rotary Vane Feeder Drum Life by 200%

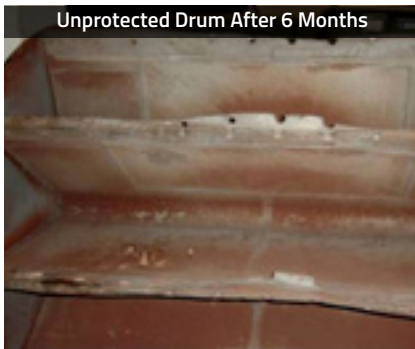
Vane pockets are damaged by wear and corrosion and must be replaced.

Vane pockets on a rotating drum inside the rotary vane feeder are fabricated from unprotected steel and not sufficiently resistant to sliding abrasion, fine particle erosion and corrosion. During service, surface material loss on the vane pockets from wear and corrosion is severe and the drum requires replacement after 6 months.

After 6 months of service, the unprotected drum suffered significant wear and corrosion damage and required replacement. An inspection after 12 months, the drum protected by Weartech SHS showed minimal material loss from surface wear to be 0.059 in (1.5 mm) and no corrosion damage.

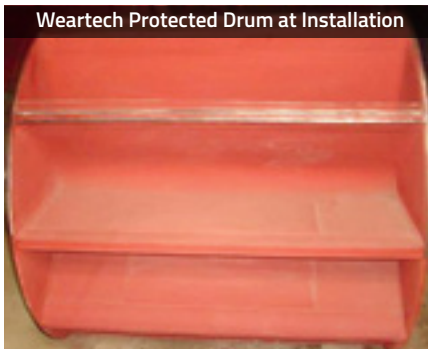
Weartech overlay wear plate and thermal spray coating are for resisting wear and corrosion.

To extend the life of rotary vane feeder drums at a cement plant in South America, Weartech® SHS™9192U wear plate, 0.748 in (19 mm) thickness, is installed in the center of each vane pocket for abrasion and impact resistance. A Weartech SHS7170 WTWAS coating, 0.039 in (1 mm) thickness, is applied to the wear plate and remaining drum surface for wear and corrosion resistance.

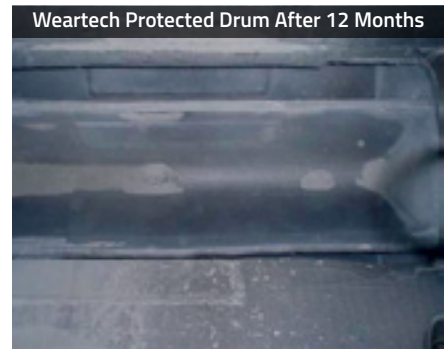
Vane pockets show minimal wear and no corrosion damage.
