## Weartech® SHS™ Coating and Overlay Wear Plate

Extend Blower Fan Blade Service Life by 300%

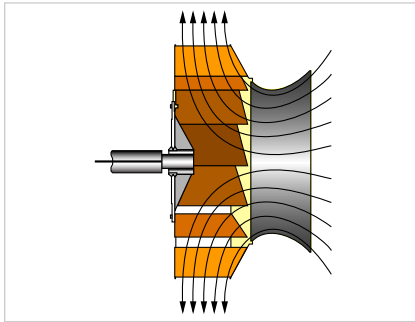
Distribution of hot gases ( $\leq 500^{\circ}\text{C}$ ) inside cement plant industrial centrifugal blower.

Industrial centrifugal blowers in cement plants provide ventilation of hot gases ( $\leq 500^{\circ}\text{C}$ ) rich with fine particle dust expelled from high temperature environments inside preheat towers, clinker ovens and clinker coolers.

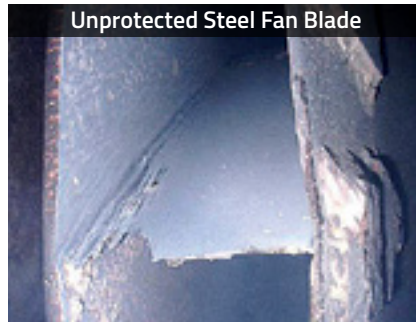
Unprotected steel fan blades are worn and must be replaced after 2-4 months of service.

At a cement plant in South America, blower fan blades mounted inside a pair of discs are fabricated from unprotected Q&T steel and not sufficiently resistant to the combination of abrasion, fine particle erosion and corrosion that they are exposed to during service. Material loss from wear and corrosion is severe, requiring replacement after only 2-4 months of service.

After only 2-4 months of service, unprotected steel fan blades are worn through and must be replaced. However, fan blade and disc surfaces protected by Weartech SHS9192U overlay wear plate and Weartech SHS 7170 WTWAS coating show minimal wear after 12 months.

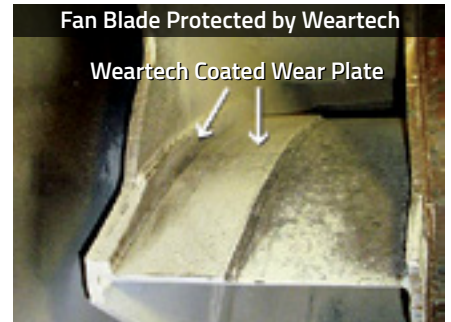
Fan blade with Weartech wear plate and coating after 12 months of service.

A Weartech® SHS™9192U overlay wear plate, 0.236 in (6 mm) thickness, for resisting severe abrasion is installed on fan blade and disc ID surface exposed to greatest amount of wear. A Weartech SHS7170 WTWAS coating, 0.039 (1 mm) thickness, for resisting fine particle erosion and corrosion is applied to the overlay wear plate and remaining fan blade and disc ID and OD surfaces.
